PRODUCT INFORMATION BULLETIN # 161810 FIRE - RSL

Issue date: 16 Oct 2018
Bulletin number: 161810

Subject: SWS Fire RSL system

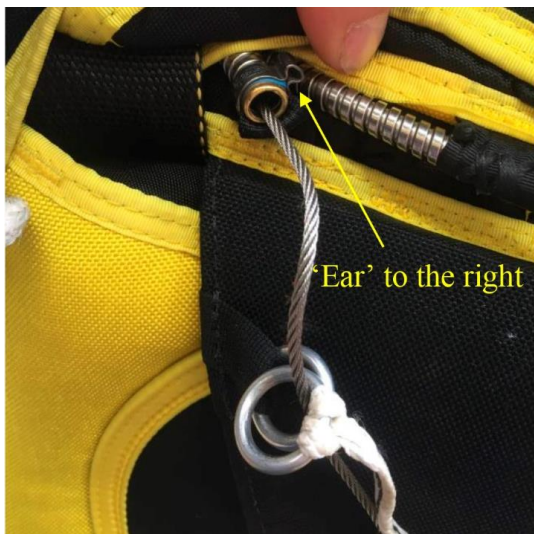
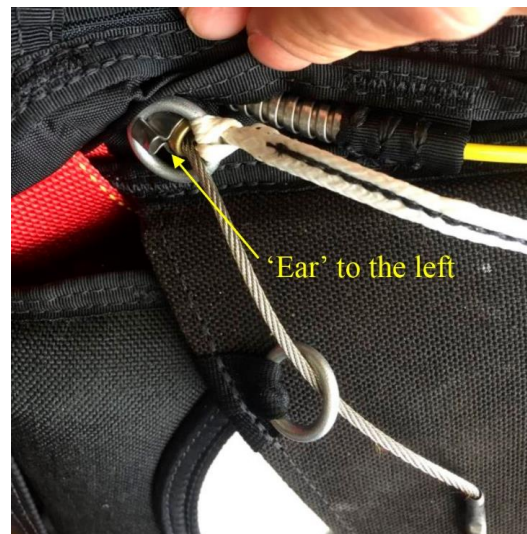
In September 2018 several BPA riggers applied to SWS company being worried about the possibility of the RSL ring to snag on the “ear” of the reserve cable housing, in case if the “ear” turns to the left.

Despite that no cases of snagging have been recorded up to date, and we consider the snagging is possible only in case of applying extra manual force, some preventive actions need to be done.

Using a seal thread to tie ring on the RSL to the guide ring on the reserve flap with a single wrap of the thread, as shown in figure 3.
